Essroc's raw feed production increased with new liner system

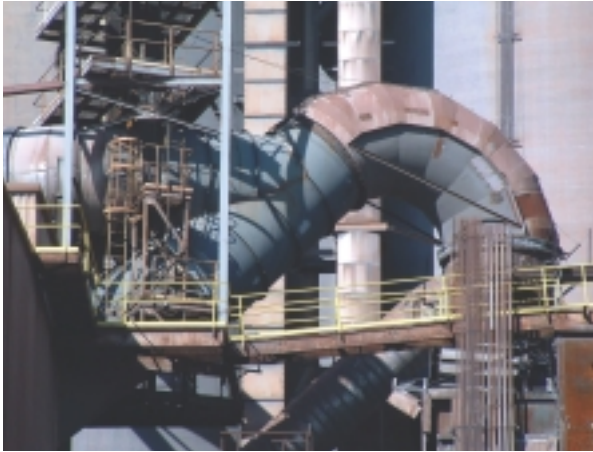
Upon closer examination of the production process, the plant engineering staff determined that a critical 48-degree elbow between the raw mill and the electrostatic precipitator was causing the diminished airflows. This 8-ft-diam elbow not only carried limestone dust but also had a second source of kiln dust that was introduced into the air

stream. This combination of highly abrasive fines and elevated temperatures riddled the elbow with holes. Plant maintenance regularly patched the elbow with abrasion resistant steel plates and ceramic wearing compounds, spending roughly 140 work-hours per year on the problem.

This 8-ft-diam, 48-degree elbow between the raw mill and the electrostatic precipitator was causing diminished airflows.

During the 1998 spring shutdown, the raw mill elbow was lined with Weller Wear Flex 2000, a process that took place over seven days. A.J. Weller provided a technician to oversee the installation and train a local refractory company hired by Essroc. Internal staging was used to aid in the installation. Prior to installation, the existing liner system, a combination of a ceramic and a wear resistant compound, was removed. Then the components of the anchoring system were welded into place. It was determined that minimal metal work was needed because WellerDensit added structural strength to the substrate. A 1 1/4-in.-thick liner was deemed appropriate for the job and was installed.

The Nazareth Plant I is in the process of modifying its dust collection system. During the 2003 shutdown, the raw mill elbow was lowered to the ground to allow for a modification in the ductwork leading into the precipitator. This gave plant personnel an opportunity to inspect the raw mill elbow and make any necessary repairs before being lifted into place. A minimal amount of repairs were needed to restore the elbow back to its original WellerDensit liner condition. This was accomplished by using a small amount of material and completed within an eight-hour window using a local mechanical maintenance contractor.
